World Trade Center Post-Disaster Reconnaissance and Perishable Structural Engineering Data Collection

Field Investigation and Analyses of the Collapse of the World Trade Center

Abolhassan Astaneh-Asl

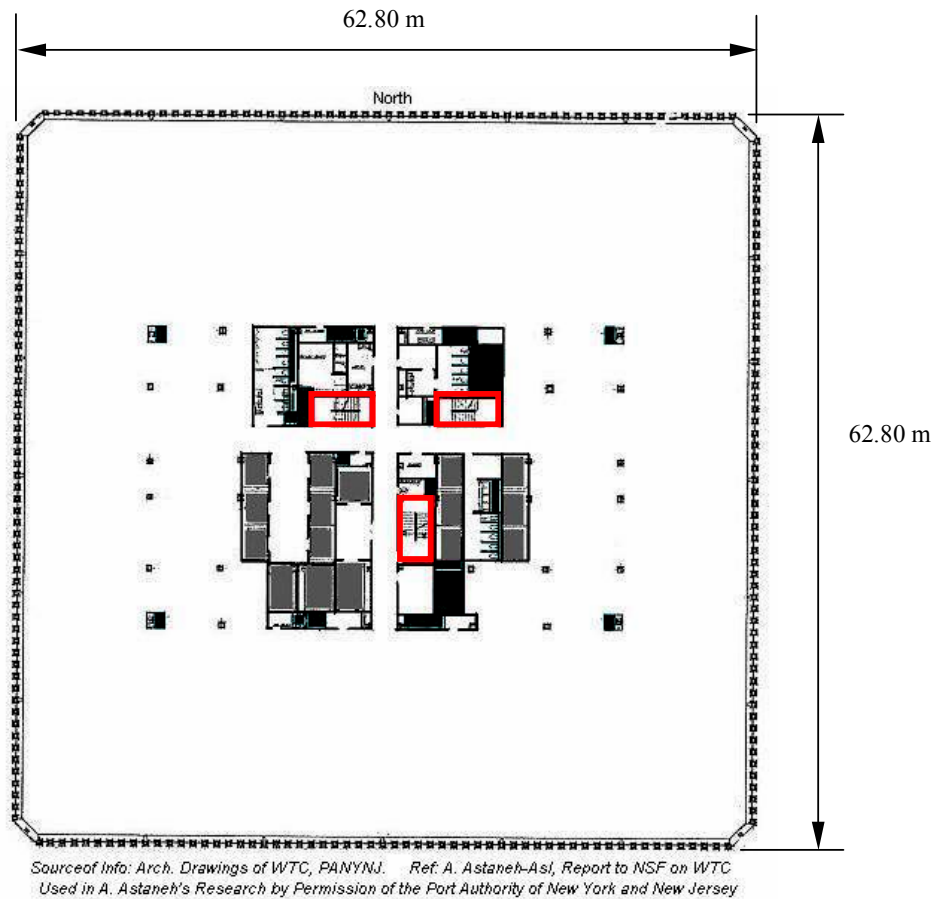
Figure 2. A Representative Architectural Plan View (96th Floor of the North Tower) (Ref: Astaneh-Asl, 2002b)

Figure 2 shows a representative architectural floor plan for the towers. The plan represents the 96th floor of the north tower. The main features of the plan are the perimeter tube, the core area and the open (column-free) office space. The perimeter tube consisted of closely spaced steel box columns and horizontal spandrel beams. The horizontal spandrel beams were steel plates only. The steel columns were spaced about 1.02 meters center to center. The dimensions of the columns were about 46 by 46 cm 14x14 inches. The opening between the two adjacent columns was about 0.56 m which was used for windows. Figure 3 shows details of exterior columns and their finishes. The steel columns of exterior tube were covered on three outside faces with sprayed on fireproofing. Aluminum façade sheets then were added to the three outside faces of the exterior columns. On the interior face, the steel columns were covered with plaster wall panels as finished surfaces of the office.

As architectural plan shown in Figure 2 indicates, the floor in the core region had numerous openings to permit passage of elevators, stairwells and a variety of utility ducts. It is not clear at this time what role these floor openings might have played in the fire that ensued after the planes entered the towers and ignited an intense fire.

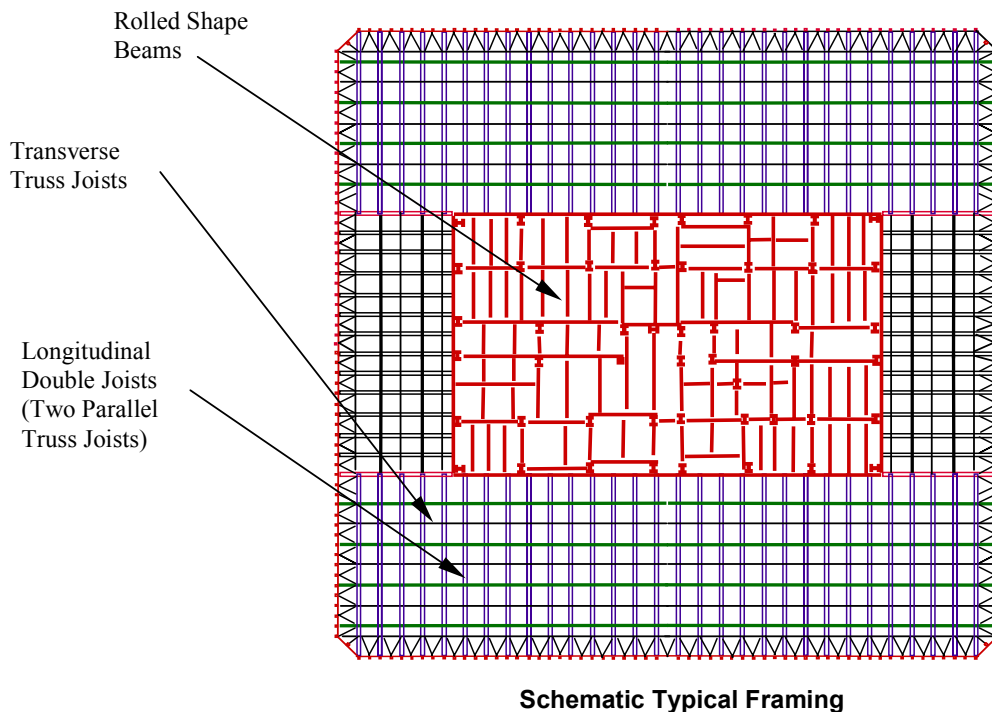
Figure 6. Typical Framing Plan and Details of Longitudinal and Transverse Trusses
(Ref: Astaneh-Asl, 2002b)

Structure of the towers was unique and consisted of three major elements: (a) an exterior steel tube, (b) an interior steel core and (c) the reinforced concrete floor slabs supported on steel truss joists which in turn were simply-supported on the exterior columns and perimeter girders of the interior steel core. Figure 6 shows a typical framing plan for the upper floors of the tower.

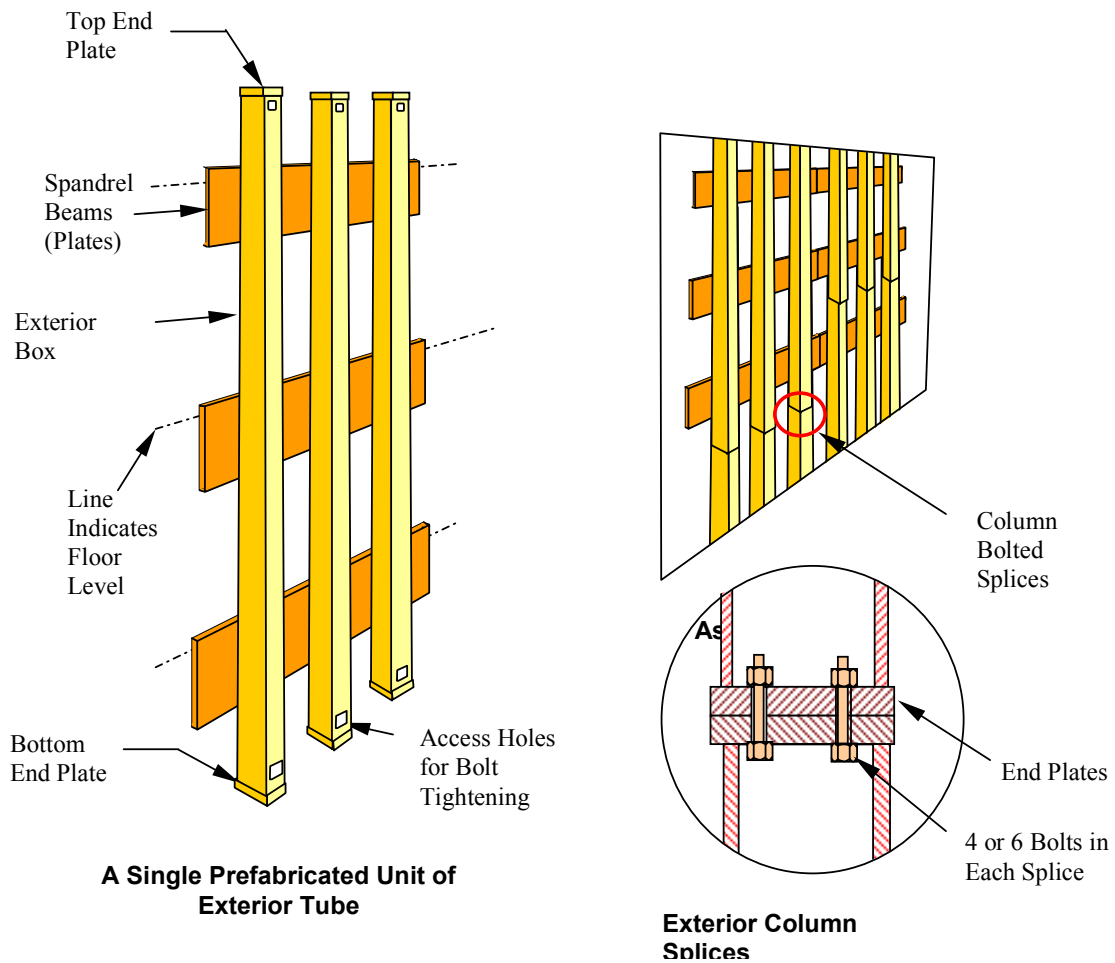
Figure 7. Prefabricated Units of Exterior Tube of the World Trade Center Towers
(Ref: Astaneh-Asl, 2002b)

The exterior steel tube consisted of 3-story pre-fabricated units such as those shown in Figure 7 with a length of about 11 m and a width of about 3 m. Each pre-fabricated unit consisted of three all-welded box-columns and three horizontal plates. The prefabricated units were field bolted during the erection process. Both ends of each column had end plates with 4 or 6 bolt holes. During the erection process these end plates were bolted to each other as shown in Figure 7. Both ends of spandrel beams on each prefabricated unit had one or two rows of holes. During erection process, two ends of spandrel plate in adjacent pre-fabricated units were connected by adding doubler plates on both sides and bolting the resulting splice. The horizontal spandrel plates were about 80 cm deep and had varied thicknesses depending on location. The horizontal plates acted as spandrel beams and were almost at the same level as the floor truss joists. It is interesting to mention that the early, pre-construction renderings of the structure show flanges for the spandrel beams. However, in the final drawings and in the as-built structure, the spandrel beams connecting the exterior columns were only plates vertically positioned as a web of a beam with no flanges.

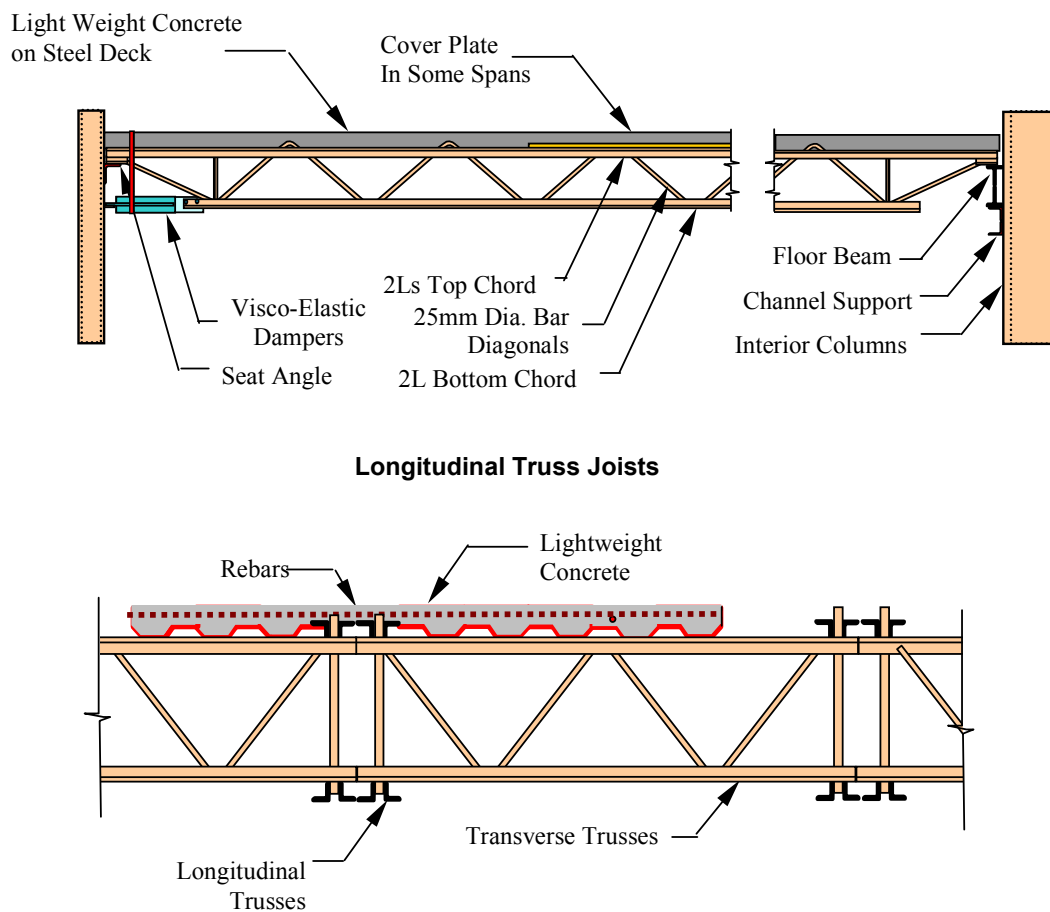
Figure 8. Longitudinal Truss Joists (top) and Transverse Truss Joists (bottom)
(Ref: Astaneh-Asl, 2002b)

The floors in the towers of World Trade Center consisted of 100 mm lightweight concrete on 40 mm corrugated steel deck making the total thickness of the floor 140 mm. The ribs in the corrugated steel deck were parallel to the longitudinal trusses. The decks were supported on transverse trusses and the transverse trusses in turn were supported on longitudinal double trusses (see Fig 6). The longitudinal double trusses had span of about 18 m and 10 m (see Fig. 6). Wire mesh and reinforcing bars were used in the slab. Figure 8 shows longitudinal and transverse trusses, their connections to columns and the crossing of transverse truss joists through the longitudinal joists. The transverse trusses were essentially supported on longitudinal double trusses. The longitudinal double trusses were in turn supported on seat angles on the exterior columns and channel beams on the perimeter of the core of the building, (see Fig. 8)

The truss joists consisted of double angle top and bottom chords and rebar diagonals. The joists were all welded. The diagonal bars had their bent above the top of the top chord acting as shear studs as shown in Figure 8. The longitudinal double joists were placed every 2032 mm and were supported on the un-stiffened seat angles welded to every other external column and on the channel beams on the perimeter of the interior core. One vertical bolt connected the end of each truss to its support angle or flange of the channel. The holes in the seat angles for these bolts were long slotted. An additional role of double joists was to brace the external columns and prevent their out of plane buckling. Every other external column was not supporting floor truss joists. To brace these columns against out of plane buckling, two plates in the shape of a V connected each Unbraced external column to the adjacent truss joists. These braces for external columns can be seen in Figure 6 around the perimeter of the floor.

3. As the plane entered the tower, the floor system between the exterior tube and interior core in front of the plane was crushed and severely damaged. This is due to the fact that the floor system, as shown earlier, was made of floor truss joists and lightweight concrete. The author could not consider the trusses to be a match to the inertia of the entering plane and stand against the plane. However, the 10-14 cm horizontal floor slabs could have caused serious damage to the plane by cutting through it while getting crushed. It is possible that at this stage, the wings which contained the jet fuel, or part of the wings, might have severed and sprayed the jet fuel over large areas of three floors that were impacted by the plane. The fire may have started at this point.

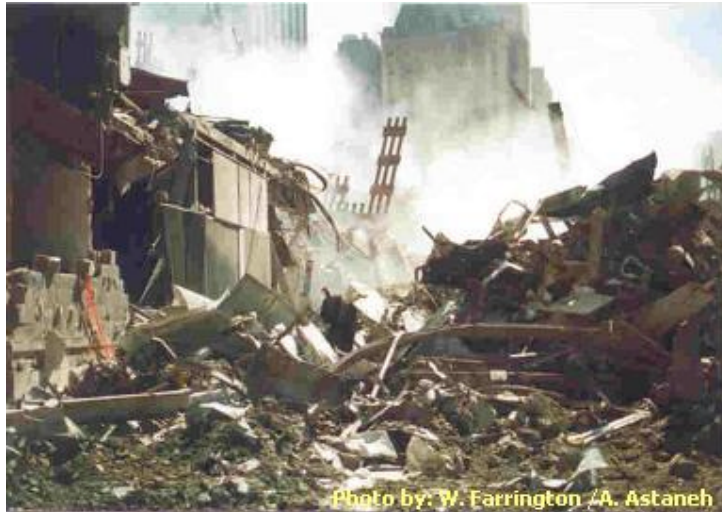
Figure 9. A View of Ground Zero, the Day After the Collapse of World Trade Center (Ref: Astaneh-Asl, 2002b)

After receiving the go-ahead from NSF, I travelled to New York City a week after the collapse and stayed for about three weeks and conducted a field investigation of the collapsed steel structures. Later, I made two more trips and further investigated the structural elements prior to their recycling. Figure 9 shows a view of the Ground Zero the day after the collapse taken by Bill Farrington (Author's photographer for this project). After arriving in New York, I met with Mr. Leslie Robertson, the lead structural engineer of the World Trade Center. After preliminary discussions on design, construction and what might have caused the collapse, the two of us along with Mr. David Morris, an architect friend of mine, who was participating and assisting me in the initial part of investigation, went to Ground Zero. At the time, Ground Zero was still burning and a large number of first responders, rescue workers, security personnel and others were working there 24 hours a day to locate and hopefully rescue survivors as well as collect data on this most heinous crime. As Figure 9 shows, Ground Zero was not a place to conduct research. This was primarily due to emotional and personal feelings of great loss and the fact that thousands of bodies of innocent people were still buried under the debris. After paying my deepest respects to all victims we left the site without stepping inside the hallowed grounds where the victims were still buried under the debris.
